Experimental Study on Seismic Behavior of Seismic-damaged Lateral Joints in Composite Frame Consisting of CFSST Columns and Steel Beams Strengthened with Enclosed Reinforced Concrete

A new composite strengthening method of seismic-damaged lateral joints in composite frame consisting of Concrete-Filled Square Steel Tubes (CFSST) columns and steel beams strengthened with enclosed Reinforced Concrete (RC) at the ends of columns and welding steel plates at the ends of beams was presented. Based on the current design specifications, one half scaled models of 4 lateral joints in composite frame consisting of CFSST columns and steel beams were designed and manufactured. One model was original control specimen, one was strengthened by enclosed RC, and the others were strengthened after pre-damage. The destruction tests under lateral cyclic load on the models were carried. The effectiveness of seismic-damaged joints strengthened with enclosed RC and the reinforcement effect on different levels of seismic damage were studied. The test results show that seismic-damaged joints in composite frame consisting of CFSST columns and steel beams strengthened with enclosed RC meets the strong column-

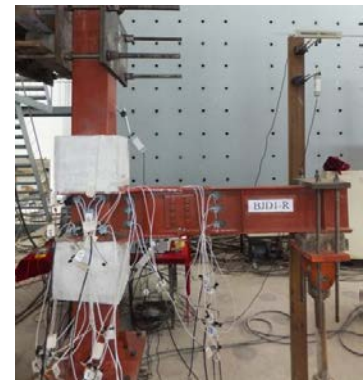
(c) Reinforcement site

FIG.5 STRENGTHENING WITH ENCLOSED RC

column end. The upper and lower column is strengthened by the enclosed concrete with longitudinal reinforcement and stirrups (Fig. 5b). Measured material properties of the longitudinal reinforcement and stirrups steel are in Table 1. The average value of the cube compressive strength of the enclosed concrete is 48.4MPa. BJDR-1, BJDR-2 and BJDR-3 were strengthened by the same method. Reinforcement site is shown in Fig. 5c.
